SANTA ANA REGIONAL WATER QUALITY CONTROL BOARD

INSPECTION REPORT

8365963001	Gerben Hettinga	GH Dairy #1
WDID No.	OWNER NAME	FACILITY NAME
CAG018001	Ex. 6 Personal Privacy (PP)	
NPDES No.	OWNER ADDRESS	FACILITY ADDRESS
Sched Date	Ontario, CA 91762	Ontario, CA 91762
	OWNER CITY, STATE & ZIP	FACILITY CITY, STATE & ZIP
12-22-10	Gerben Hettinga	Gerben Hettinga
Actual Date Inspected	OWNER CONTACT	FACILITY CONTACT
	Ex. 6 Personal Privacy (PP)	
	OWNER PHONE NO.	FACILITY PHONE NO.

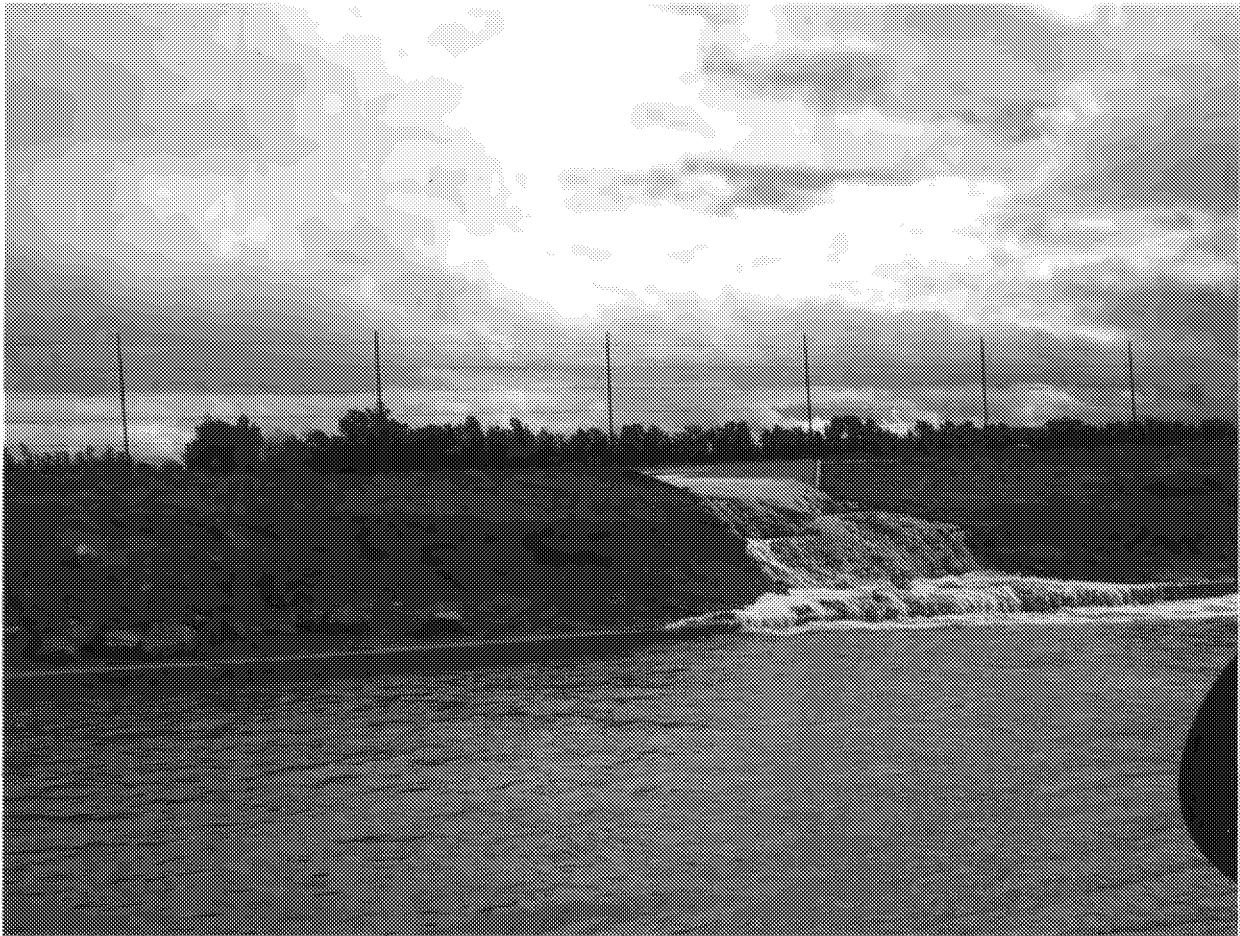
CONDITION OF BERMS AND CONTAINMENT STRUCTURES: During stormwatch reconnaissance, manured water was observed flowing over the spillway located in the west berm at the southwest corner of the retention pond. The wastewater was discharging onto Grove Avenue at about 200 gpm. Wastewater was also observed discharging from rodent holes located in the south berm along Merrill Avenue. (Refer to Photos)

Photo #1 View looking southeast from Grove Avenue. Area is at the southwest corner of the facility. Spillway is constructed in west berm of retention pond.

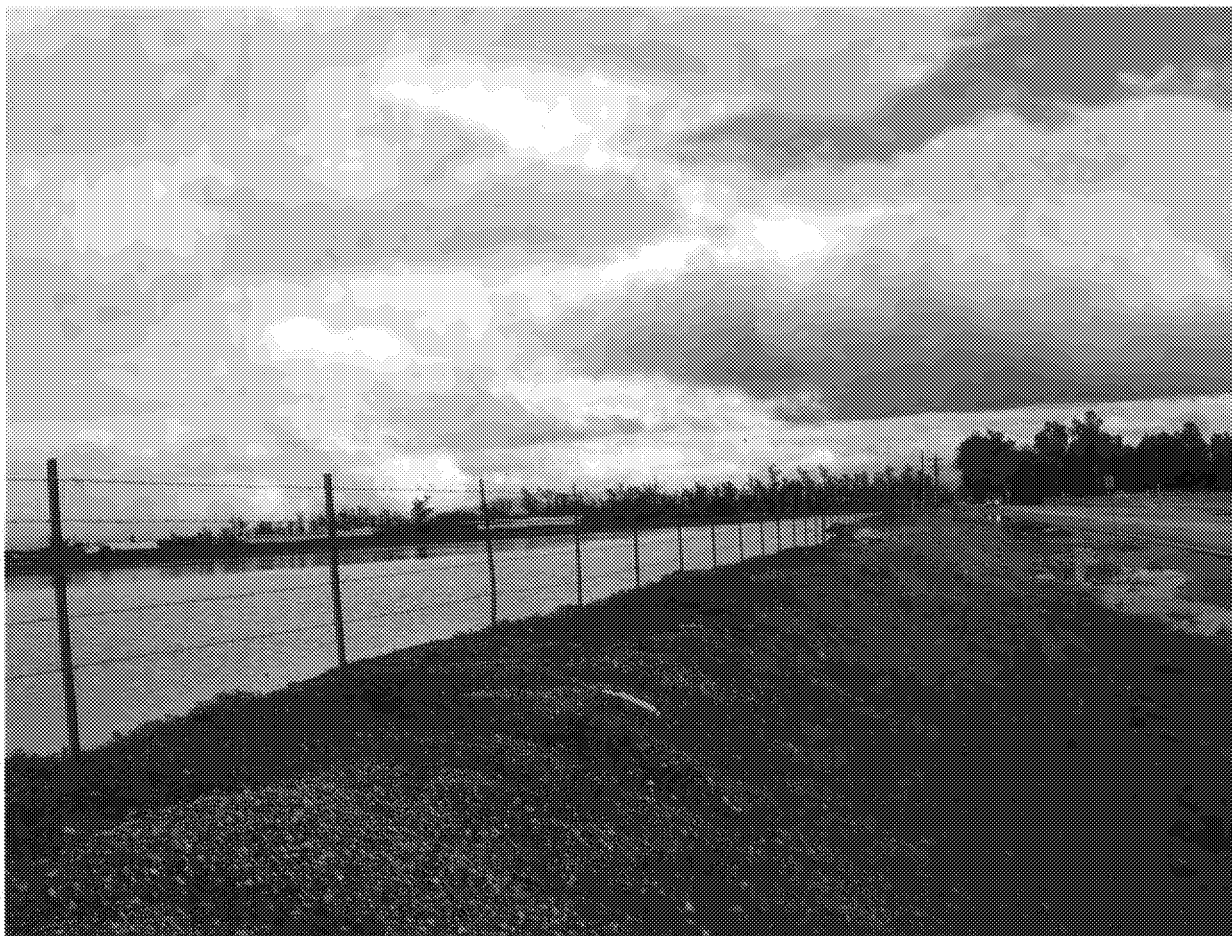
Photo #2 View looking east along Merrill Avenue. Facility wastewater retention pond at middle left. Water along shoulder of Merrill Avenue is from pond.

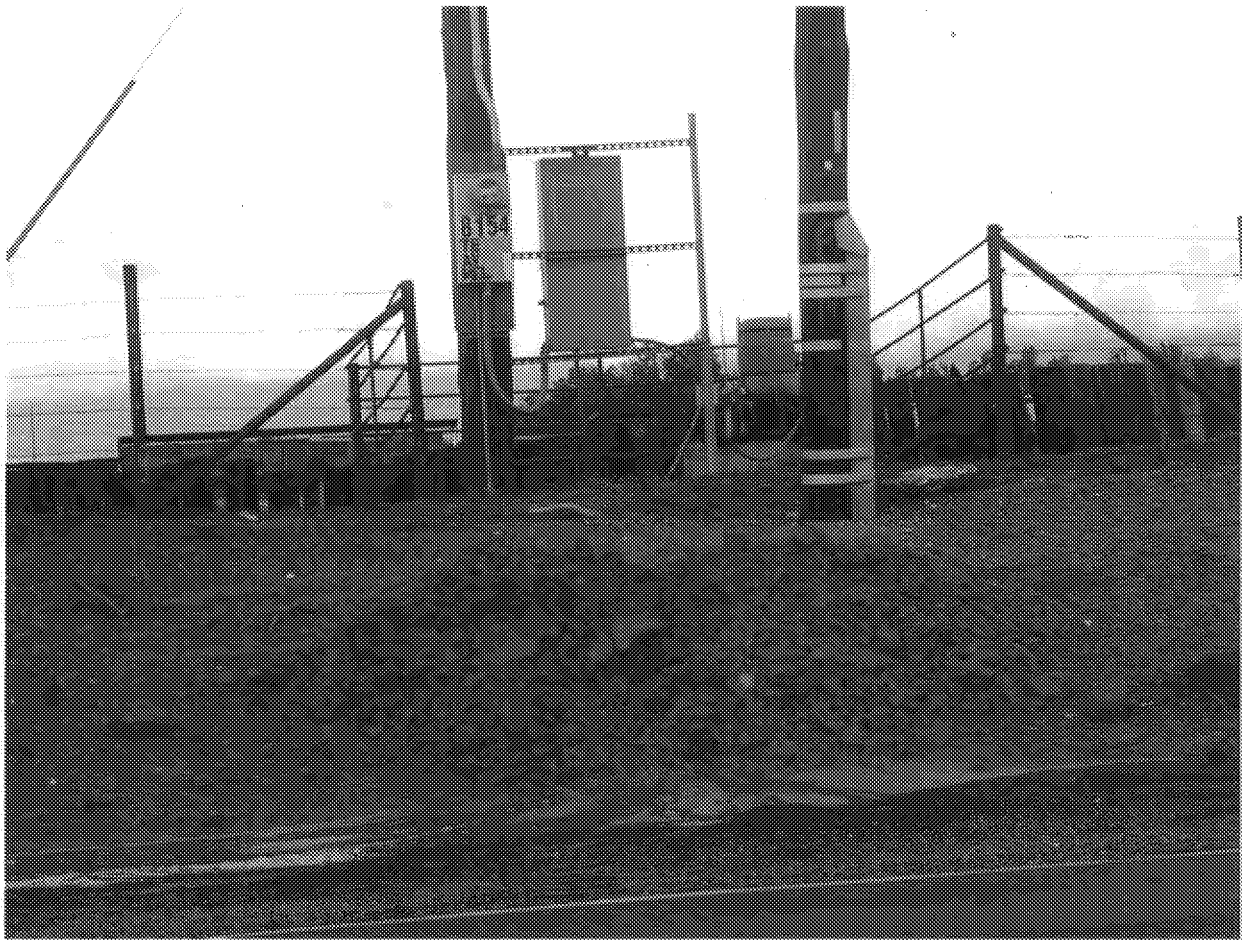
Photo #3 View looking north from Merrill Avenue. View of south berm with wastewater discharge from rodent hole (lower middle).

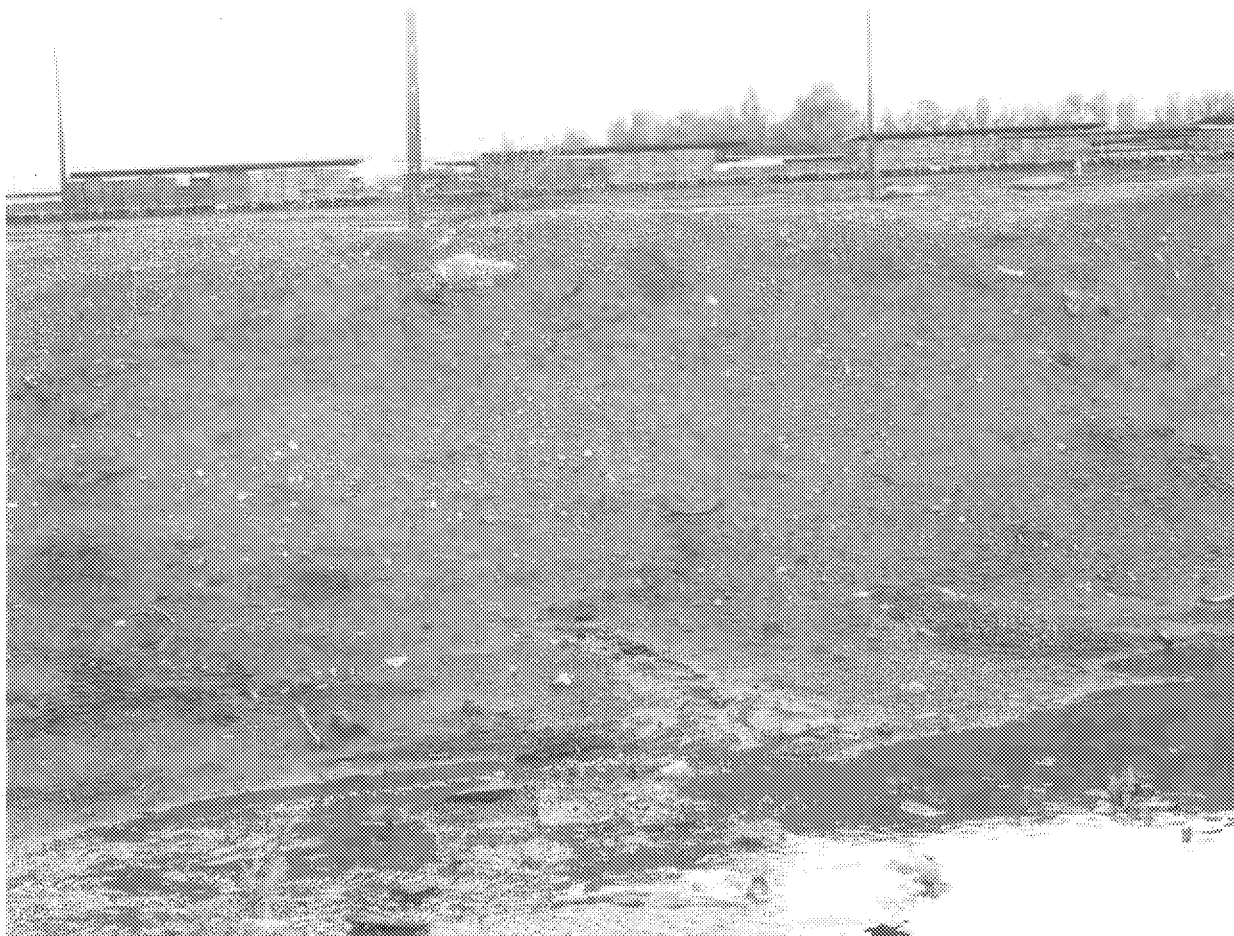
Photo #4 View looking north at south berm located along Merrill Avenue. Discharge of wastewater from rodent hole flowing onto shoulder of Merrill Avenue.

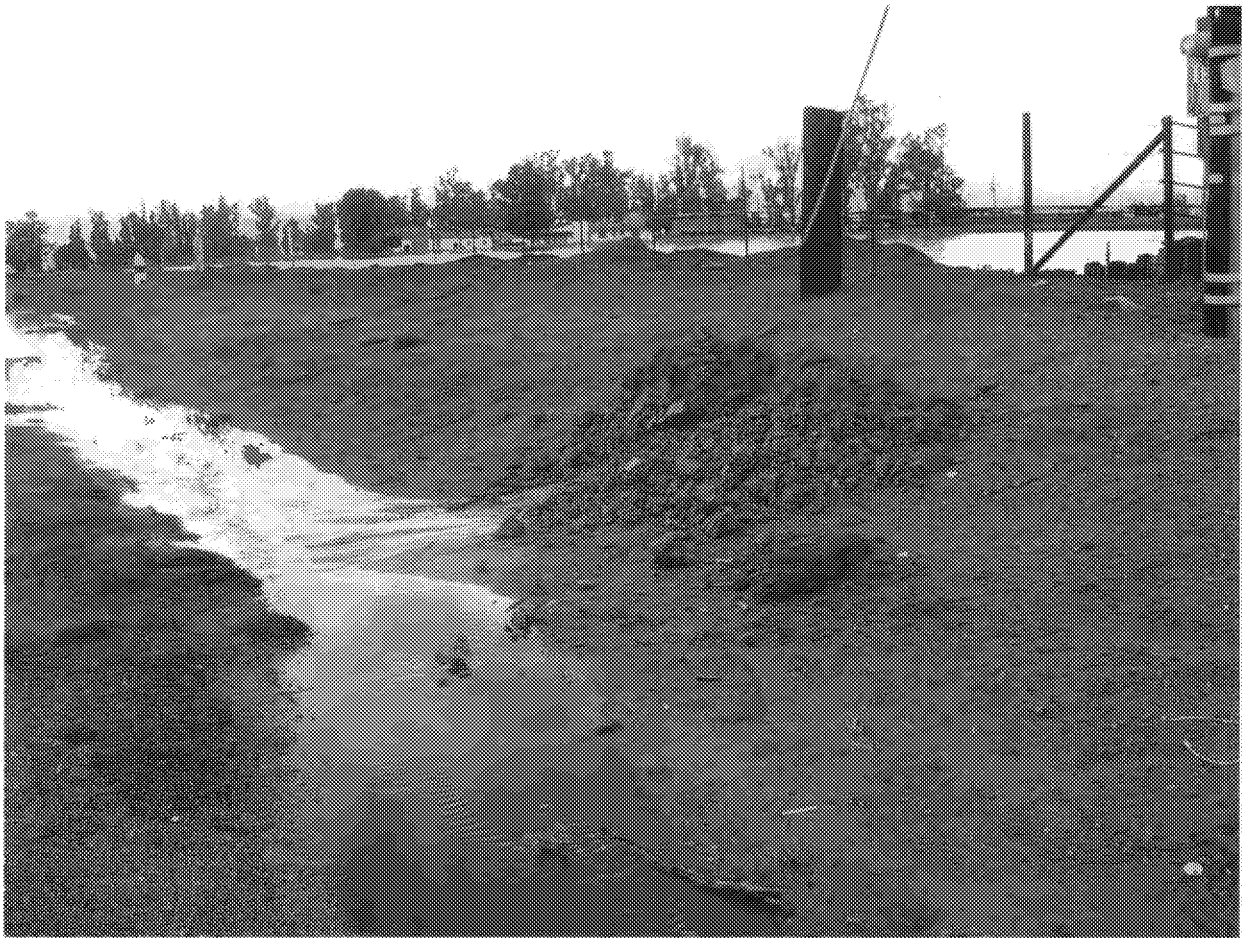
Photo #5 View looking west along shoulder of Merrill Avenue. Different photo angle of wastewater discharge from rodent hole as shown in photo #3.

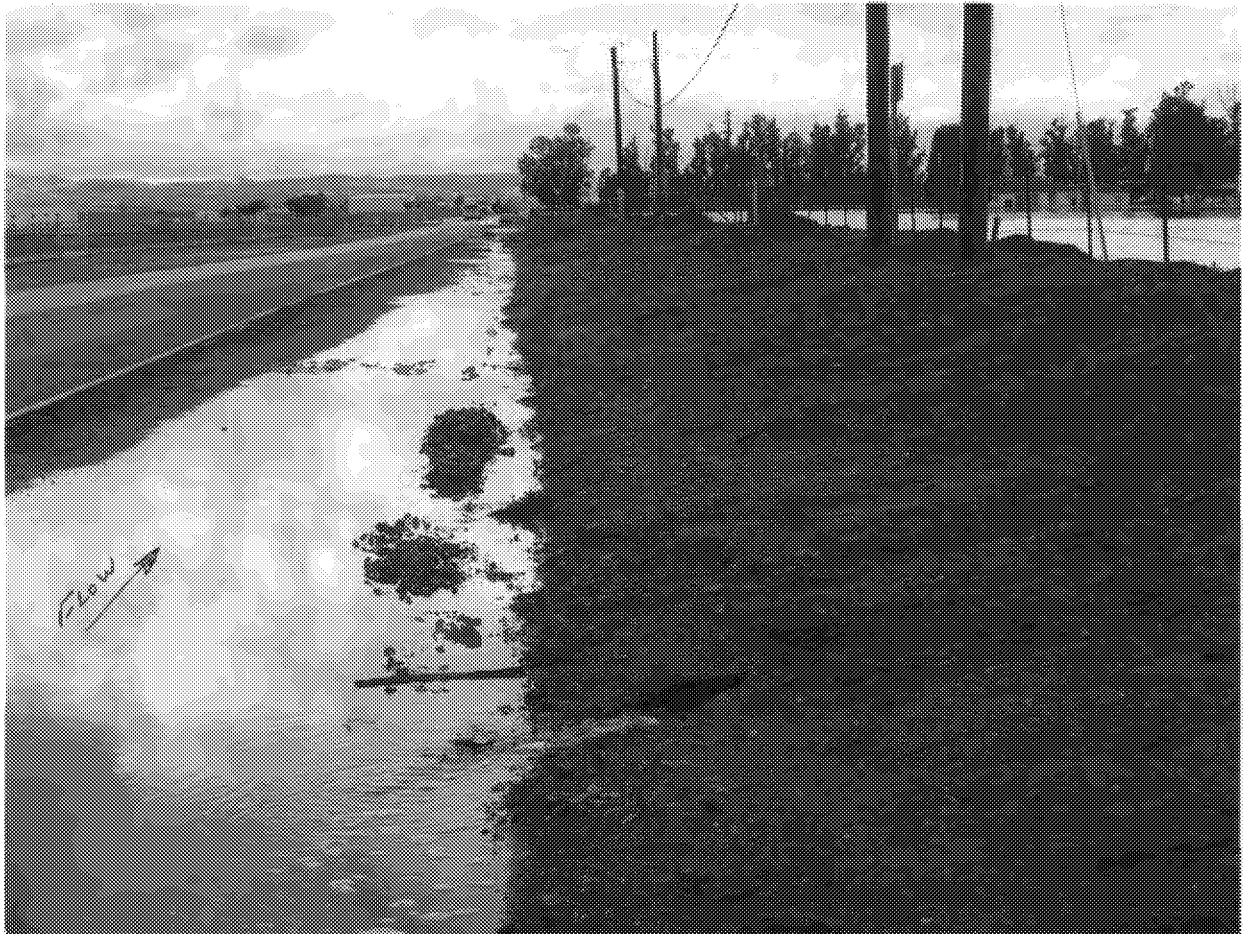
Photo #6 View looking west along Merrill Avenue. Wastewater discharge from rodent hole in south berm. Water flow along Merrill is from lower left to upper middle.

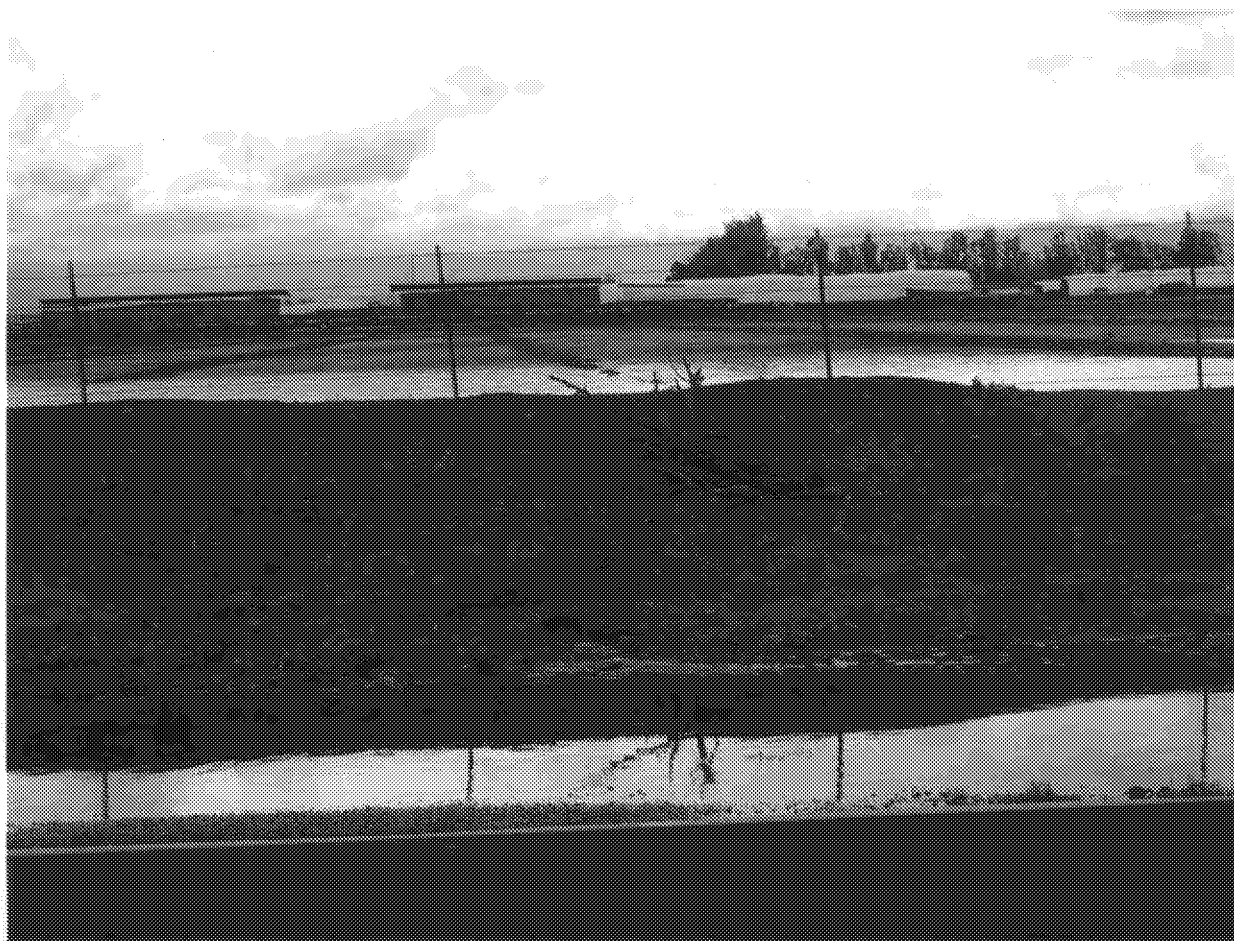
Photo #7 View looking north at south berm along Merrill Avenue. Wastewater discharging onto Merrill Avenue from rodent hole in berm. Different photo angle as that in photo #6.
